Maryland Inventory of Historic Properties number: BA-2778

Name: BOZZY / Mount Vista bl over Broad Run

MARYLAND INVENTORY OF HISTORIC BRIDGES
HISTORIC BRIDGE INVENTORY
MARYLAND STATE HIGHWAY ADMINISTRATION/
MARYLAND HISTORICAL TRUST

SHA Bridge No. B 0224 Bridge name Mount Vista Road over Broad Run

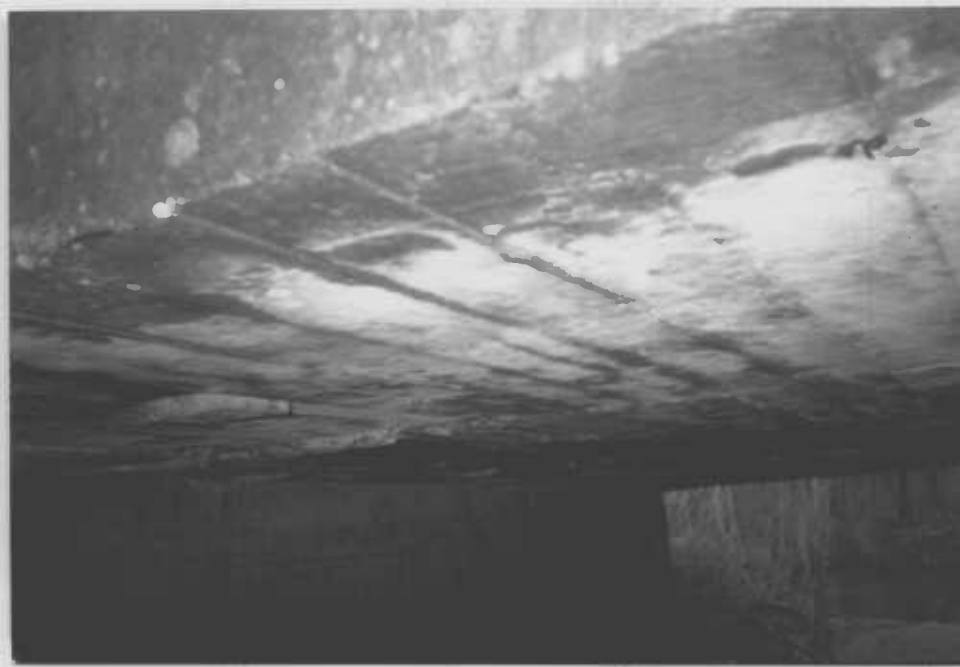
1. BA-2778
2. Mt. Vista Rd over Broad Run
3. BALTO. County (B0224)
4. ERIC Griffiths
5. 3-97
6. MD SHPO
7. detail of slab under deck
8. 1 of 6

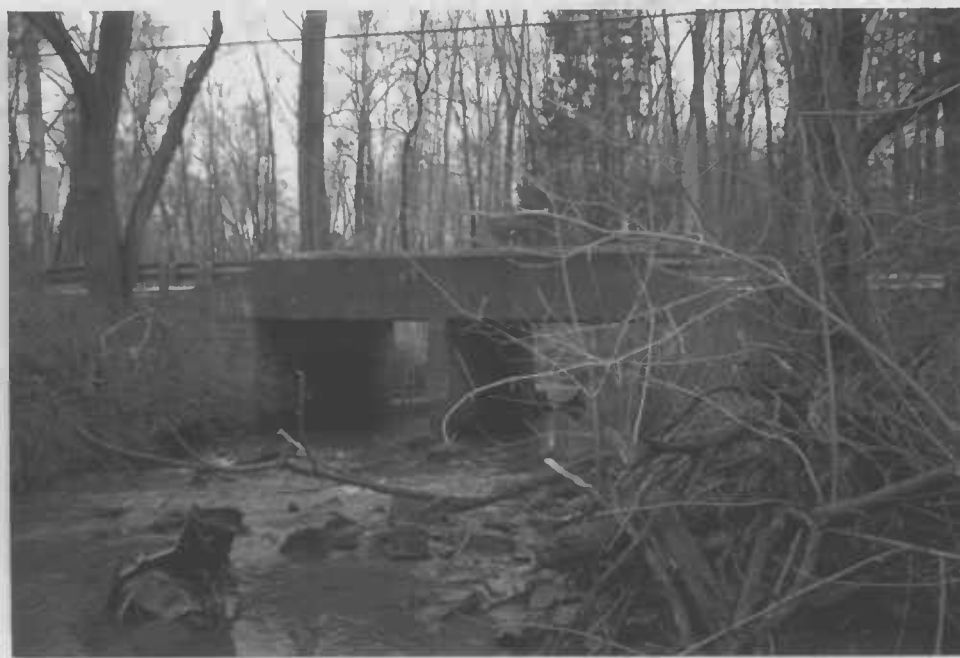
- 1 BA-2778
- 2 mt. Vista Rd over Broad Run
(B0224)
- 3 BA/HO. County
- 4 Eric Griffiths
- 5 3-97
- 6 MD SHPD
- 7 South Elevation
- 8 2 of 6

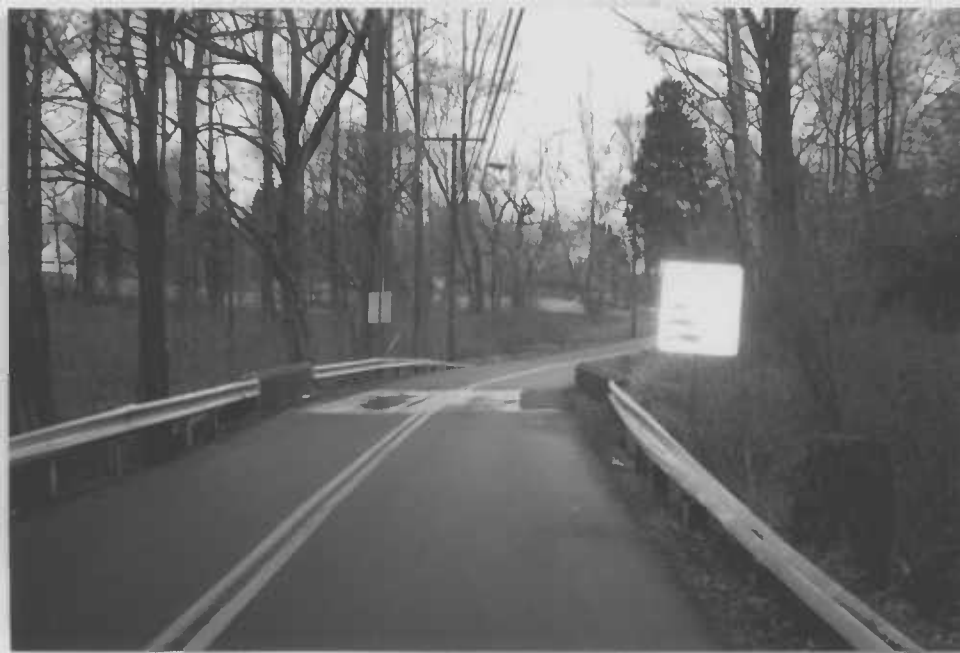
- 1 BA-2778
- 2 Mt. Vista near Brook Run
(BA224)
- 3 BA Mt. County
- 4 ERIC GRIFFITHS
- 5 3-97
- 6 MD SHPD
- 7 West Approach
- 8 3 of 6

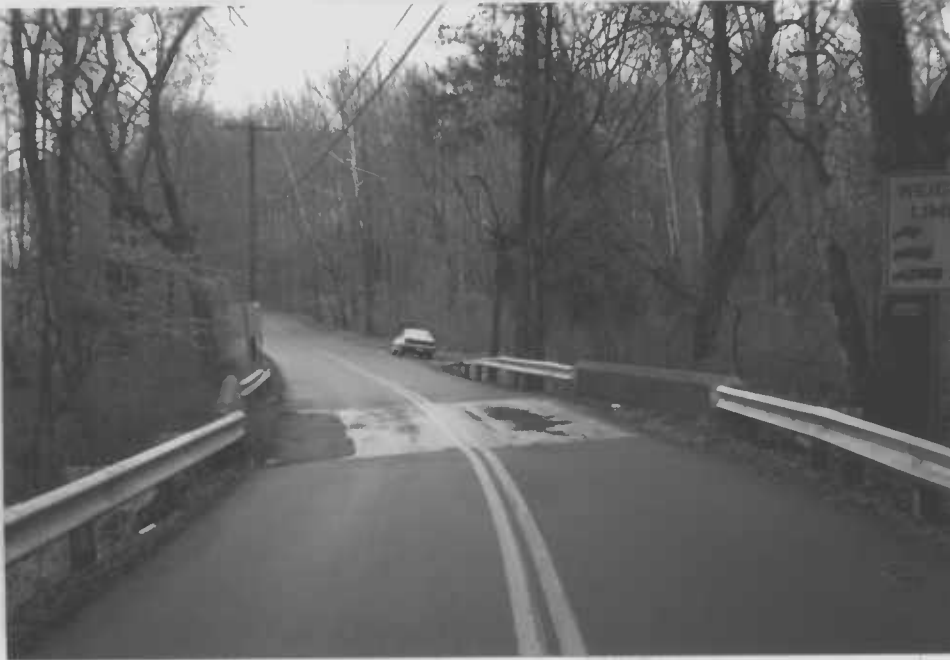
1. BA-2778
2. Mt. Vista Rd near Brook Run
(B0224)
3. Bath Co. County
4. ERIC Griffiths
5. 3-97
6. MD SHPO
7. EAST Approach
8. 4 of 6

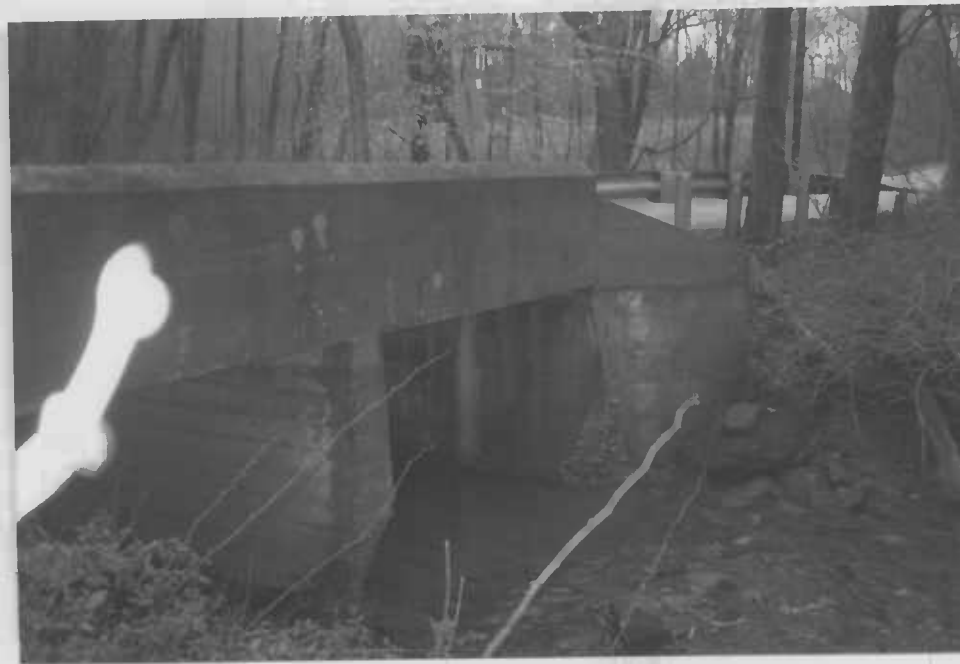
According to the 1995 inspection report, this structure was in serious condition with the slab exhibiting wide longitudinal cracks and large spalls with exposed reinforcement. The bituminous wearing surface has gouges. The wing walls have longitudinal cracks, vertical cracks and large spalls. The abutments have vertical cracking and minor spalls. The pier has severe scaling at the water line and a large spall.

- 1 BA-2778
- 2 Mt. Vista Lower Broad Run
(B0224)
- 3 BA Ho. County
- 4 ERIC Griffiths
5. 3-97
6. MD SHPO
7. detail of deterioration
Abutment & Pier
- 8 5 of 6

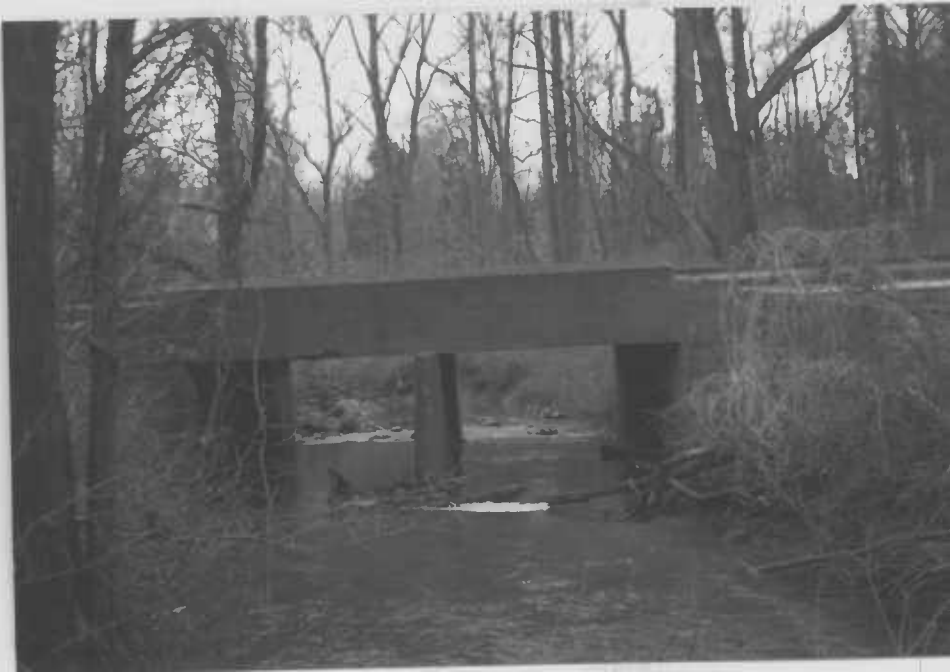
7 North Elevation
